THAMES RIVER BASIN
THOMPSON , CONNECTICUT

QUADDICK RESERVOIR DAM
CT 00184

PHASE I INSPECTION REPORT
NATIONAL DAM INSPECTION PROGRAM

FEBRUARY , 1979

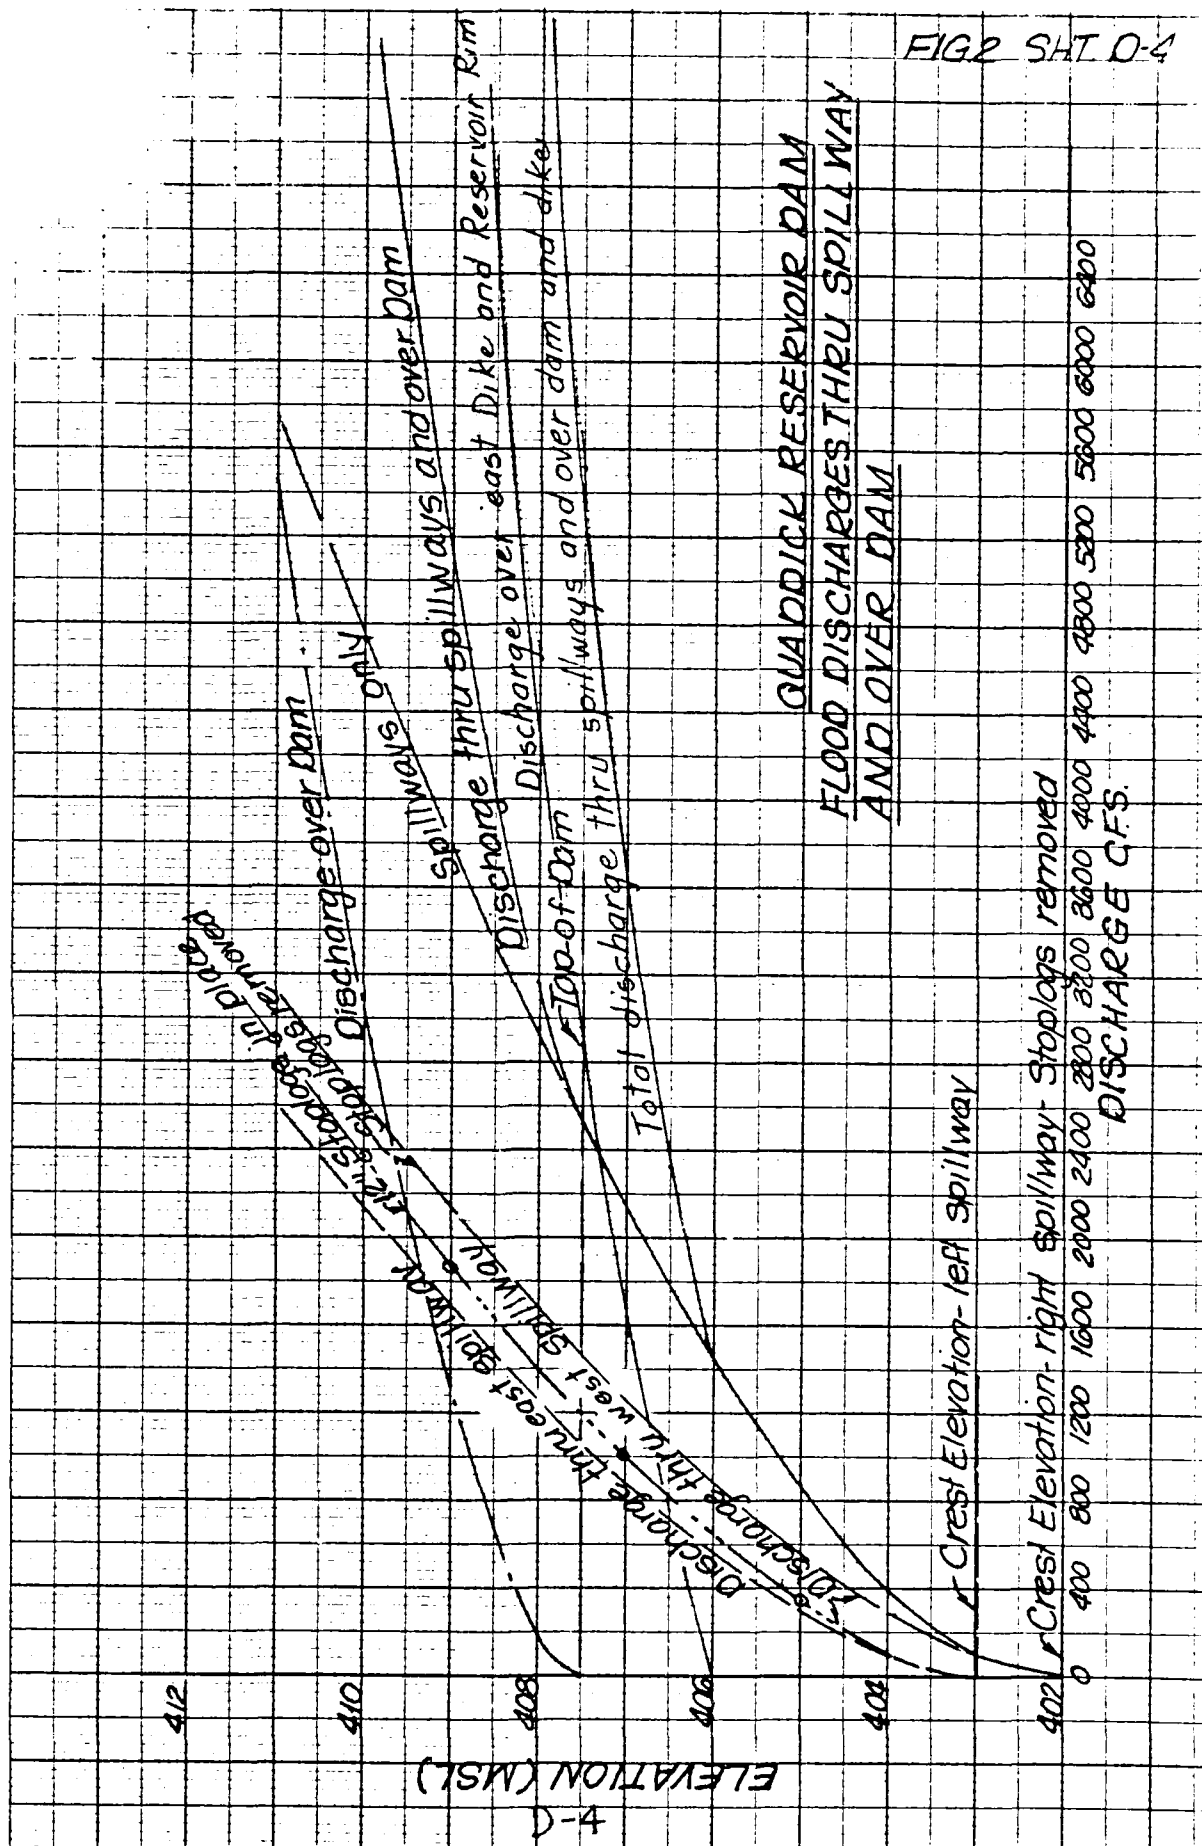
FIG. 2 SHT D-4

Spillway discharge curves have been prepared for the right spillway, with or without 12 in. stoplogs in place, for the left spillway, and for flows over the dam and dike. Discharge curves are shown on Figure 2, Sheet D-4, Appendix D. Computations are shown on Sheet D-5. Pertinent discharges are as follows:

For use in the flood routings of the inflows into Quaddick Reservoir, discharge curves for each spillway and for outflows over the dam and dike were computed, as shown on Figure 2, Sheet D-4, Appendix D.

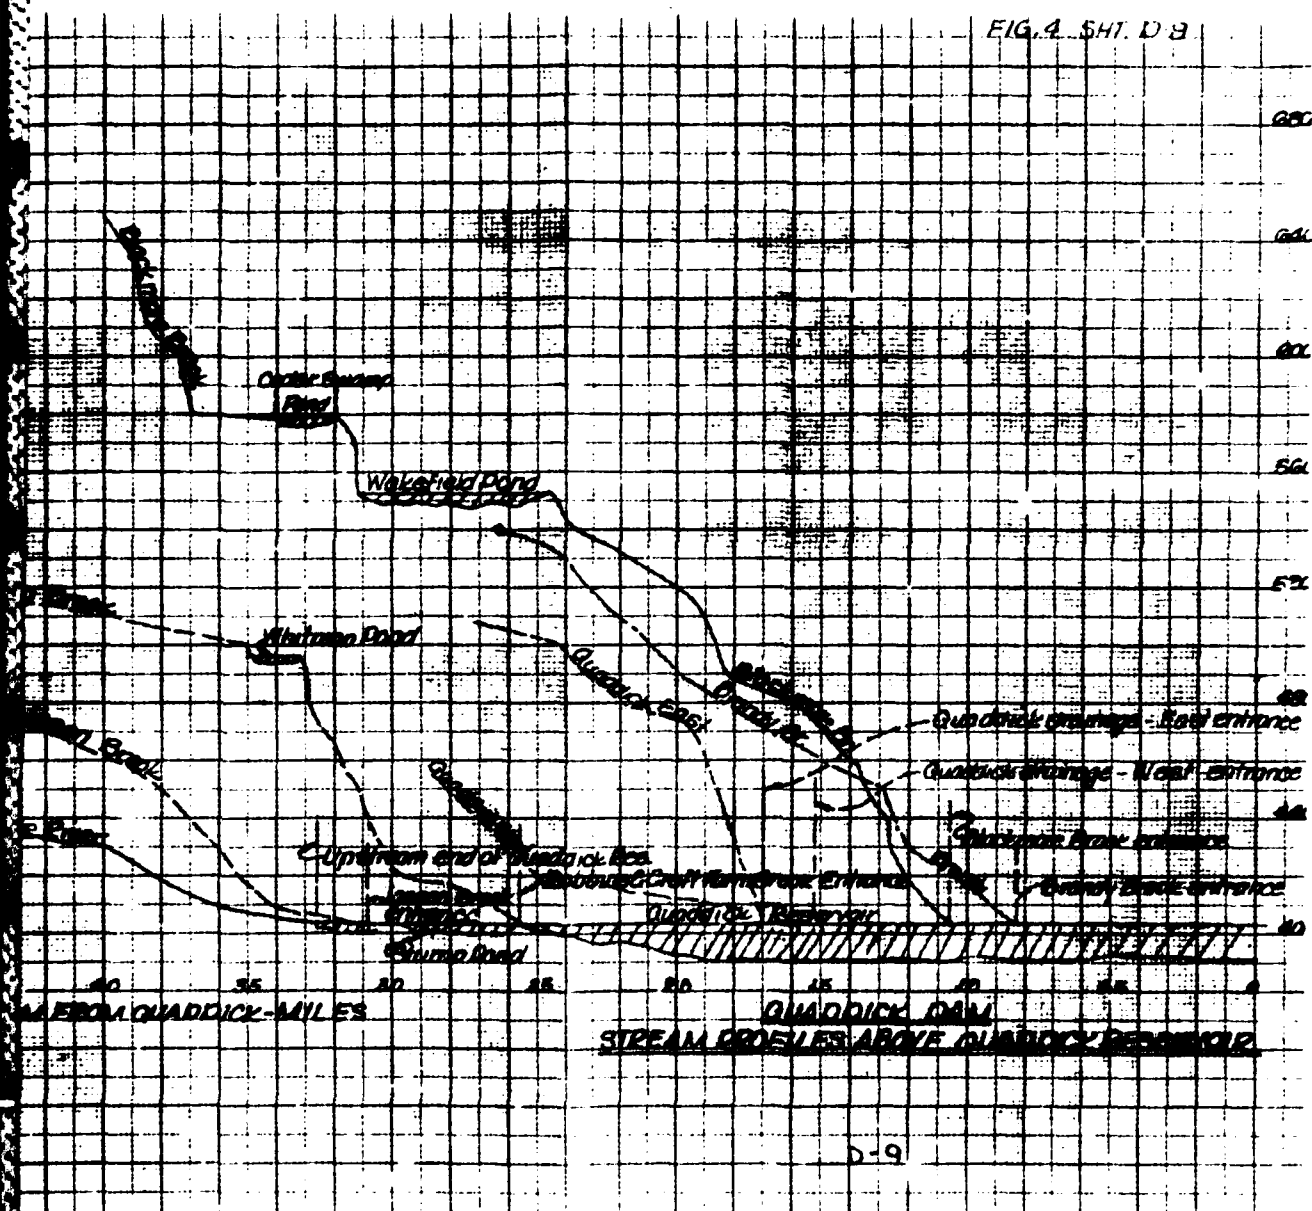
FIG. 4. SHI. D. 9

In order to evaluate the sub-drainage basin characteristics for the lag and transport times needed to develop the sub-basin hydrographs, stream profiles were plotted from the USGS quadrangle sheets. These profiles are shown on Figure 4, Sheet D-9. Stream lengths for each sub-basin were evaluated for time-of-concentration, lag time and average flow velocity. The resulting values are recorded on Sheets D-10 and D-11. A weighted average equivalent flow velocity within the various basins is about 0.9 ft. per sec. and transport velocities between sub-areas average about 1.3 ft. per sec.
